### Rensselaerville Water District Preliminary Engineering Report Town of Rensselaerville Albany County, New York

*C.T. Male Associates Project No: 24.4005*

**RENSELAERVILLE WATER DISTRICT  
PRELIMINARY ENGINEERING REPORT**

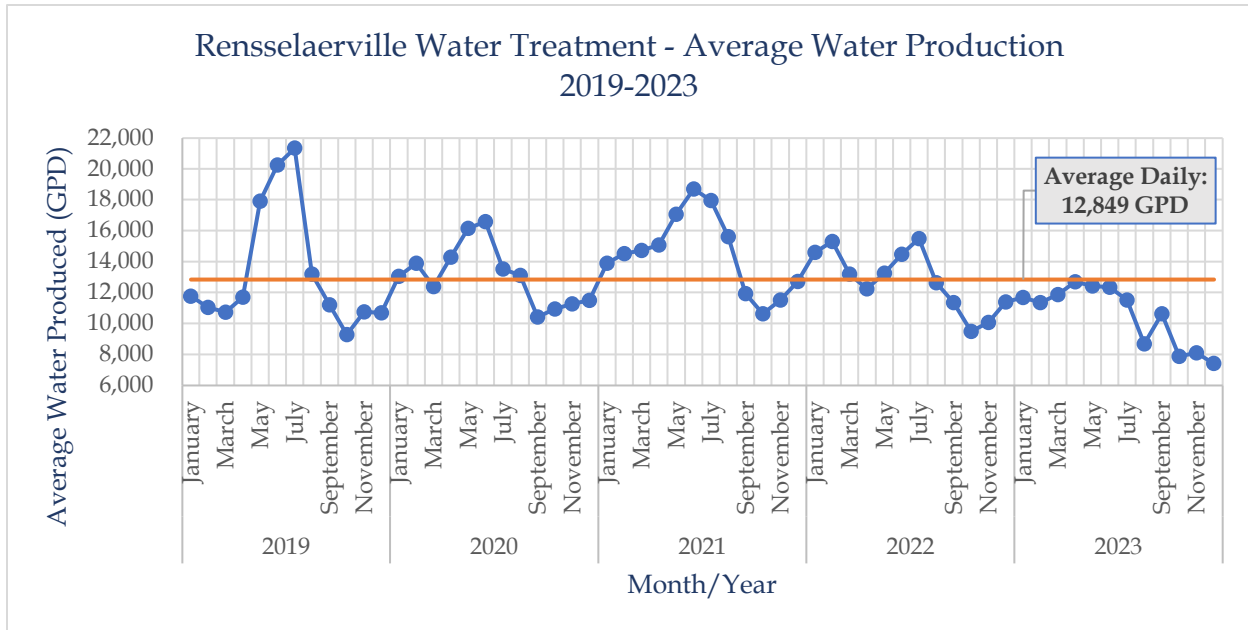
The system currently uses an average of 13,000 gallons per day (GPD) of water. A summary of the system demands and operational averages dating back to January 2019 are included in the graph below.

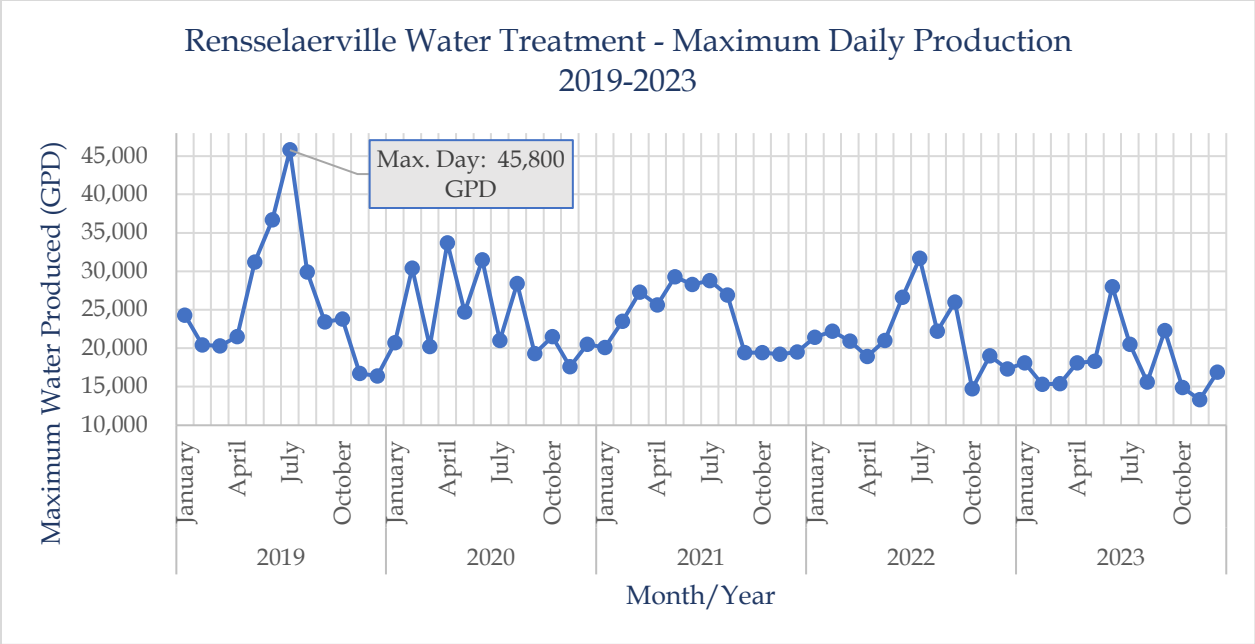
The users in the system are not metered, so it is unknown how much of the treated water is unaccounted for due to potential leaks in the system. The maximum single day production was recorded at 45,800 GPD in July 2019. Subsequent high yield days include dates in June 2019 and again in April 2020. A summary of the maximum daily production, dating back to January 2019 is included in the graph on the next page.

The water treatment plant is currently sized to treat 14,400 gallons of water per day, being controlled by the sand filter and GAC filter rates of 10 GPM. The onsite 50,000 gallon buried water storage tank is utilized to store the volumes necessary for the infrequent high demand days.

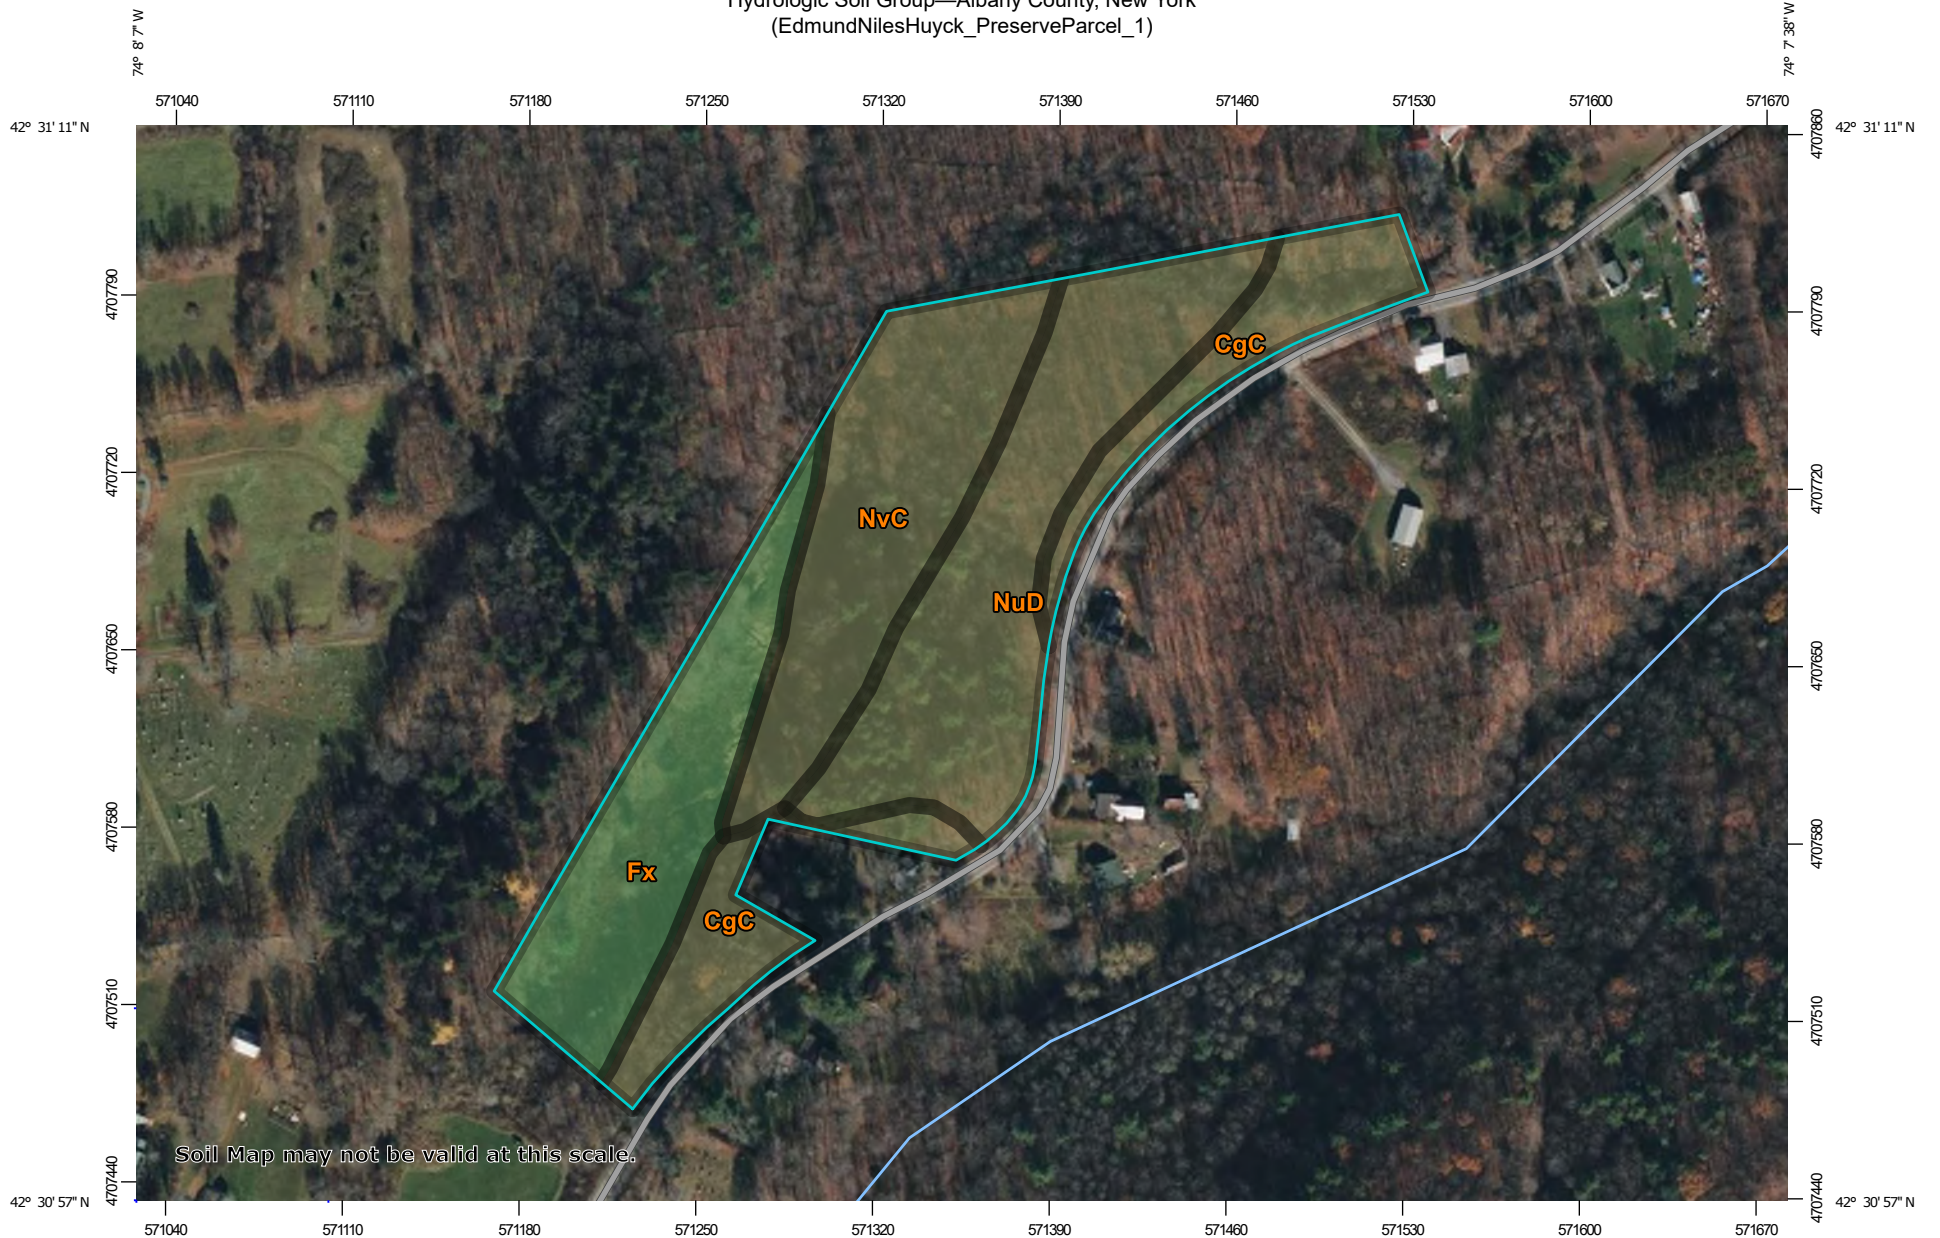
Hydrologic Soil Group—Albany County, New York  
(EdmundNilesHuyck\_PreserveParcel\_1)

Hydrologic soil groups are based on estimates of runoff potential. Soils are assigned to one of four groups according to the rate of water infiltration when the soils are not protected by vegetation, are thoroughly wet, and receive precipitation from long-duration storms.

Group A. Soils having a high infiltration rate (low runoff potential) when thoroughly wet. These consist mainly of deep, well drained to excessively drained sands or gravelly sands. These soils have a high rate of water transmission.

Group B. Soils having a moderate infiltration rate when thoroughly wet. These consist chiefly of moderately deep or deep, moderately well drained or well drained soils that have moderately fine texture to moderately coarse texture. These soils have a moderate rate of water transmission.

Group C. Soils having a slow infiltration rate when thoroughly wet. These consist chiefly of soils having a layer that impedes the downward movement of water or soils of moderately fine texture or fine texture. These soils have a slow rate of water transmission.

Group D. Soils having a very slow infiltration rate (high runoff potential) when thoroughly wet. These consist chiefly of clays that have a high shrink-swell potential, soils that have a high water table, soils that have a claypan or clay layer at or near the surface, and soils that are shallow over nearly impervious material. These soils have a very slow rate of water transmission.

If a soil is assigned to a dual hydrologic group (A/D, B/D, or C/D), the first letter is for drained areas and the second is for undrained areas. Only the soils that in their natural condition are in group D are assigned to dual classes.

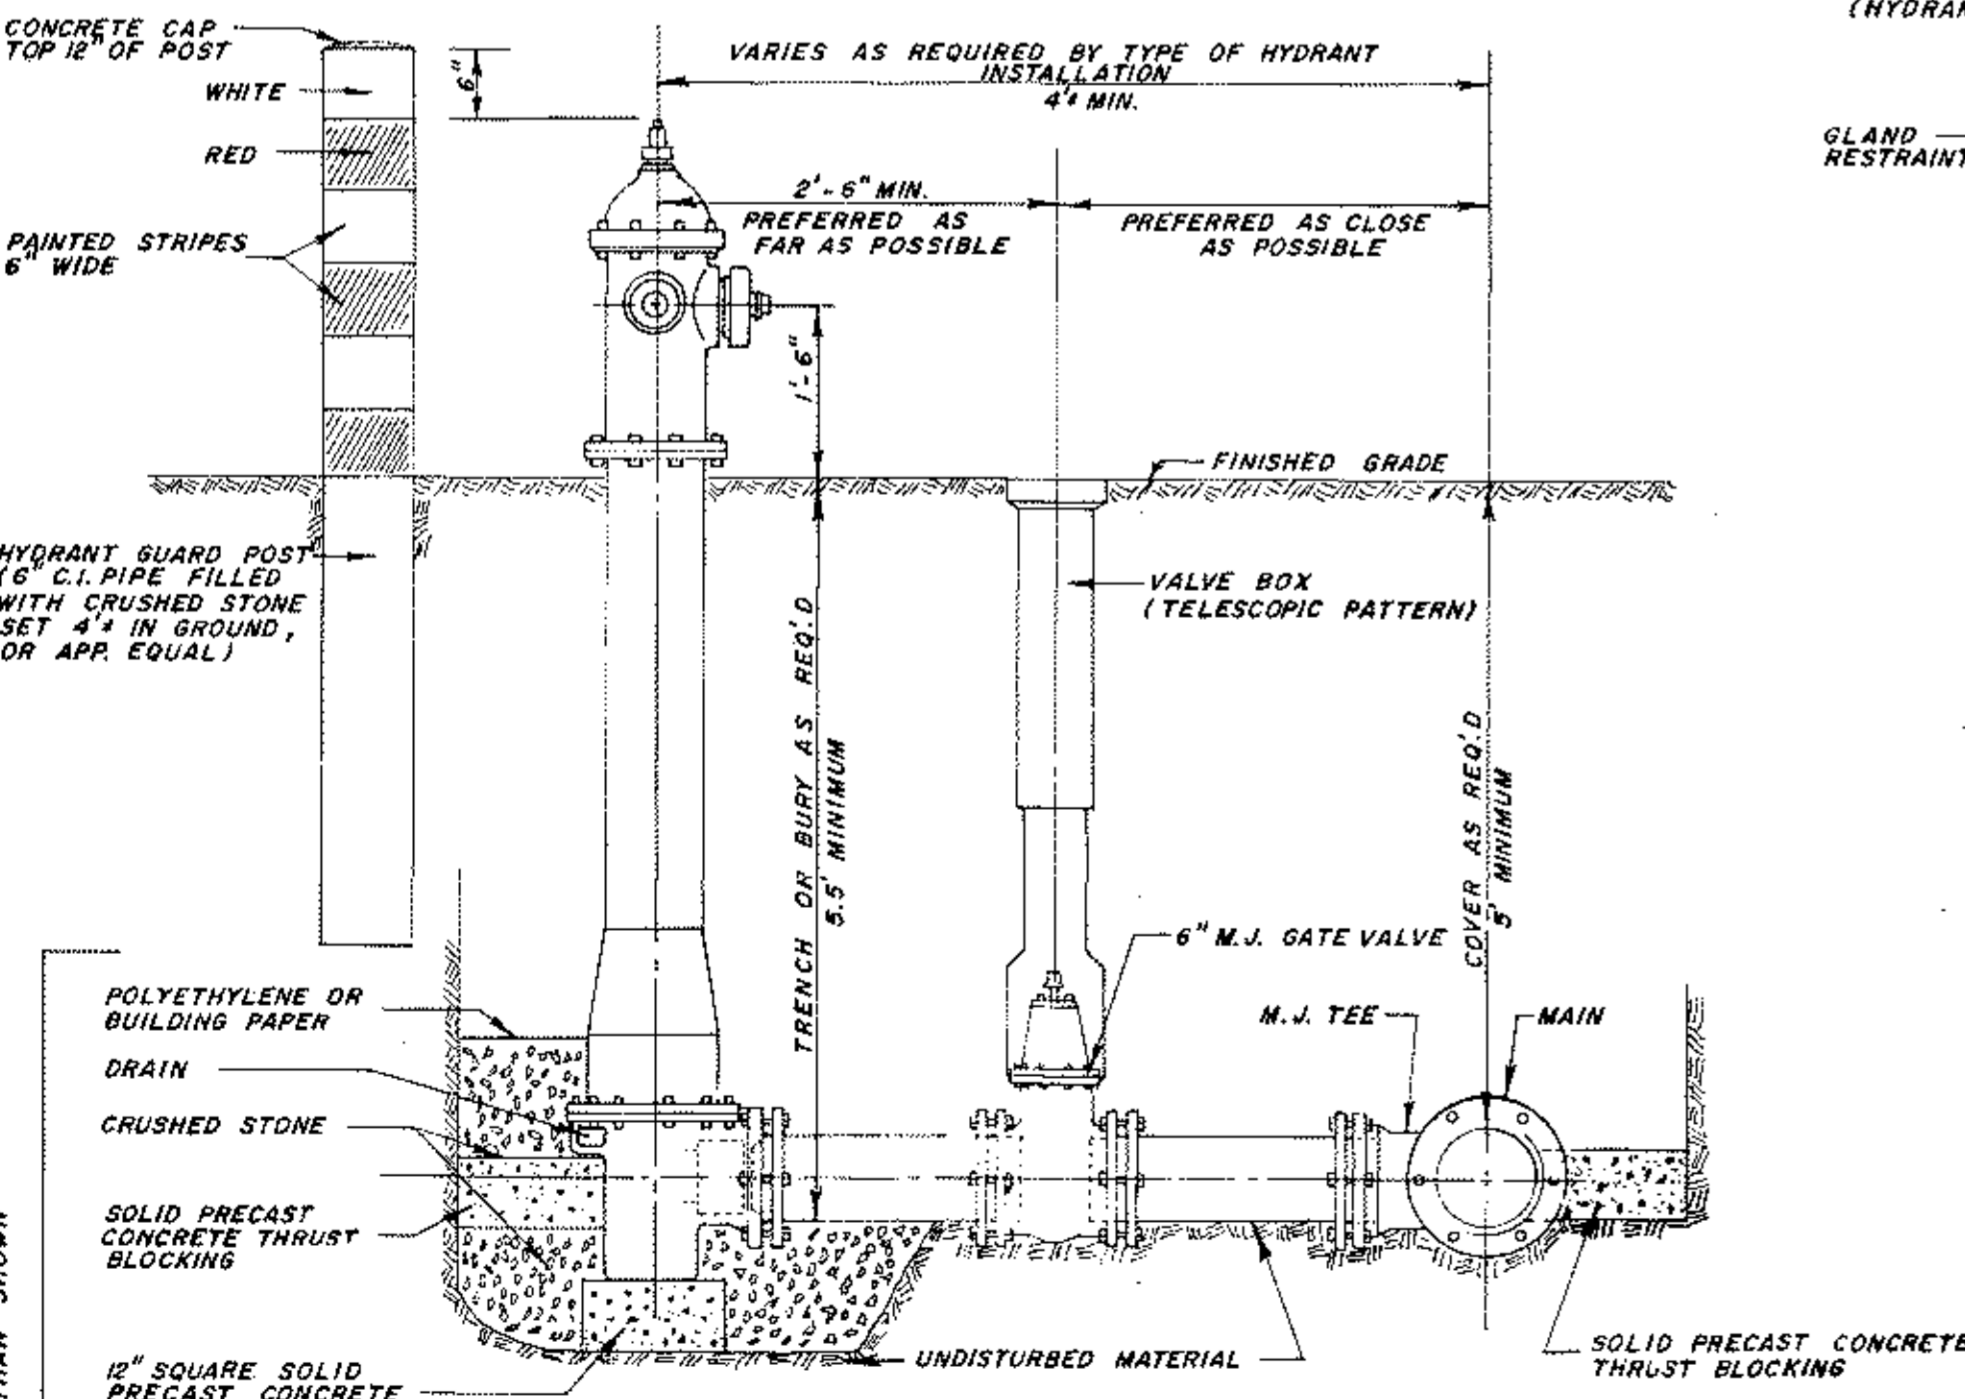
**PLAN**

**TYPICAL HYDRANT INSTALLATION**  
NO SCALE

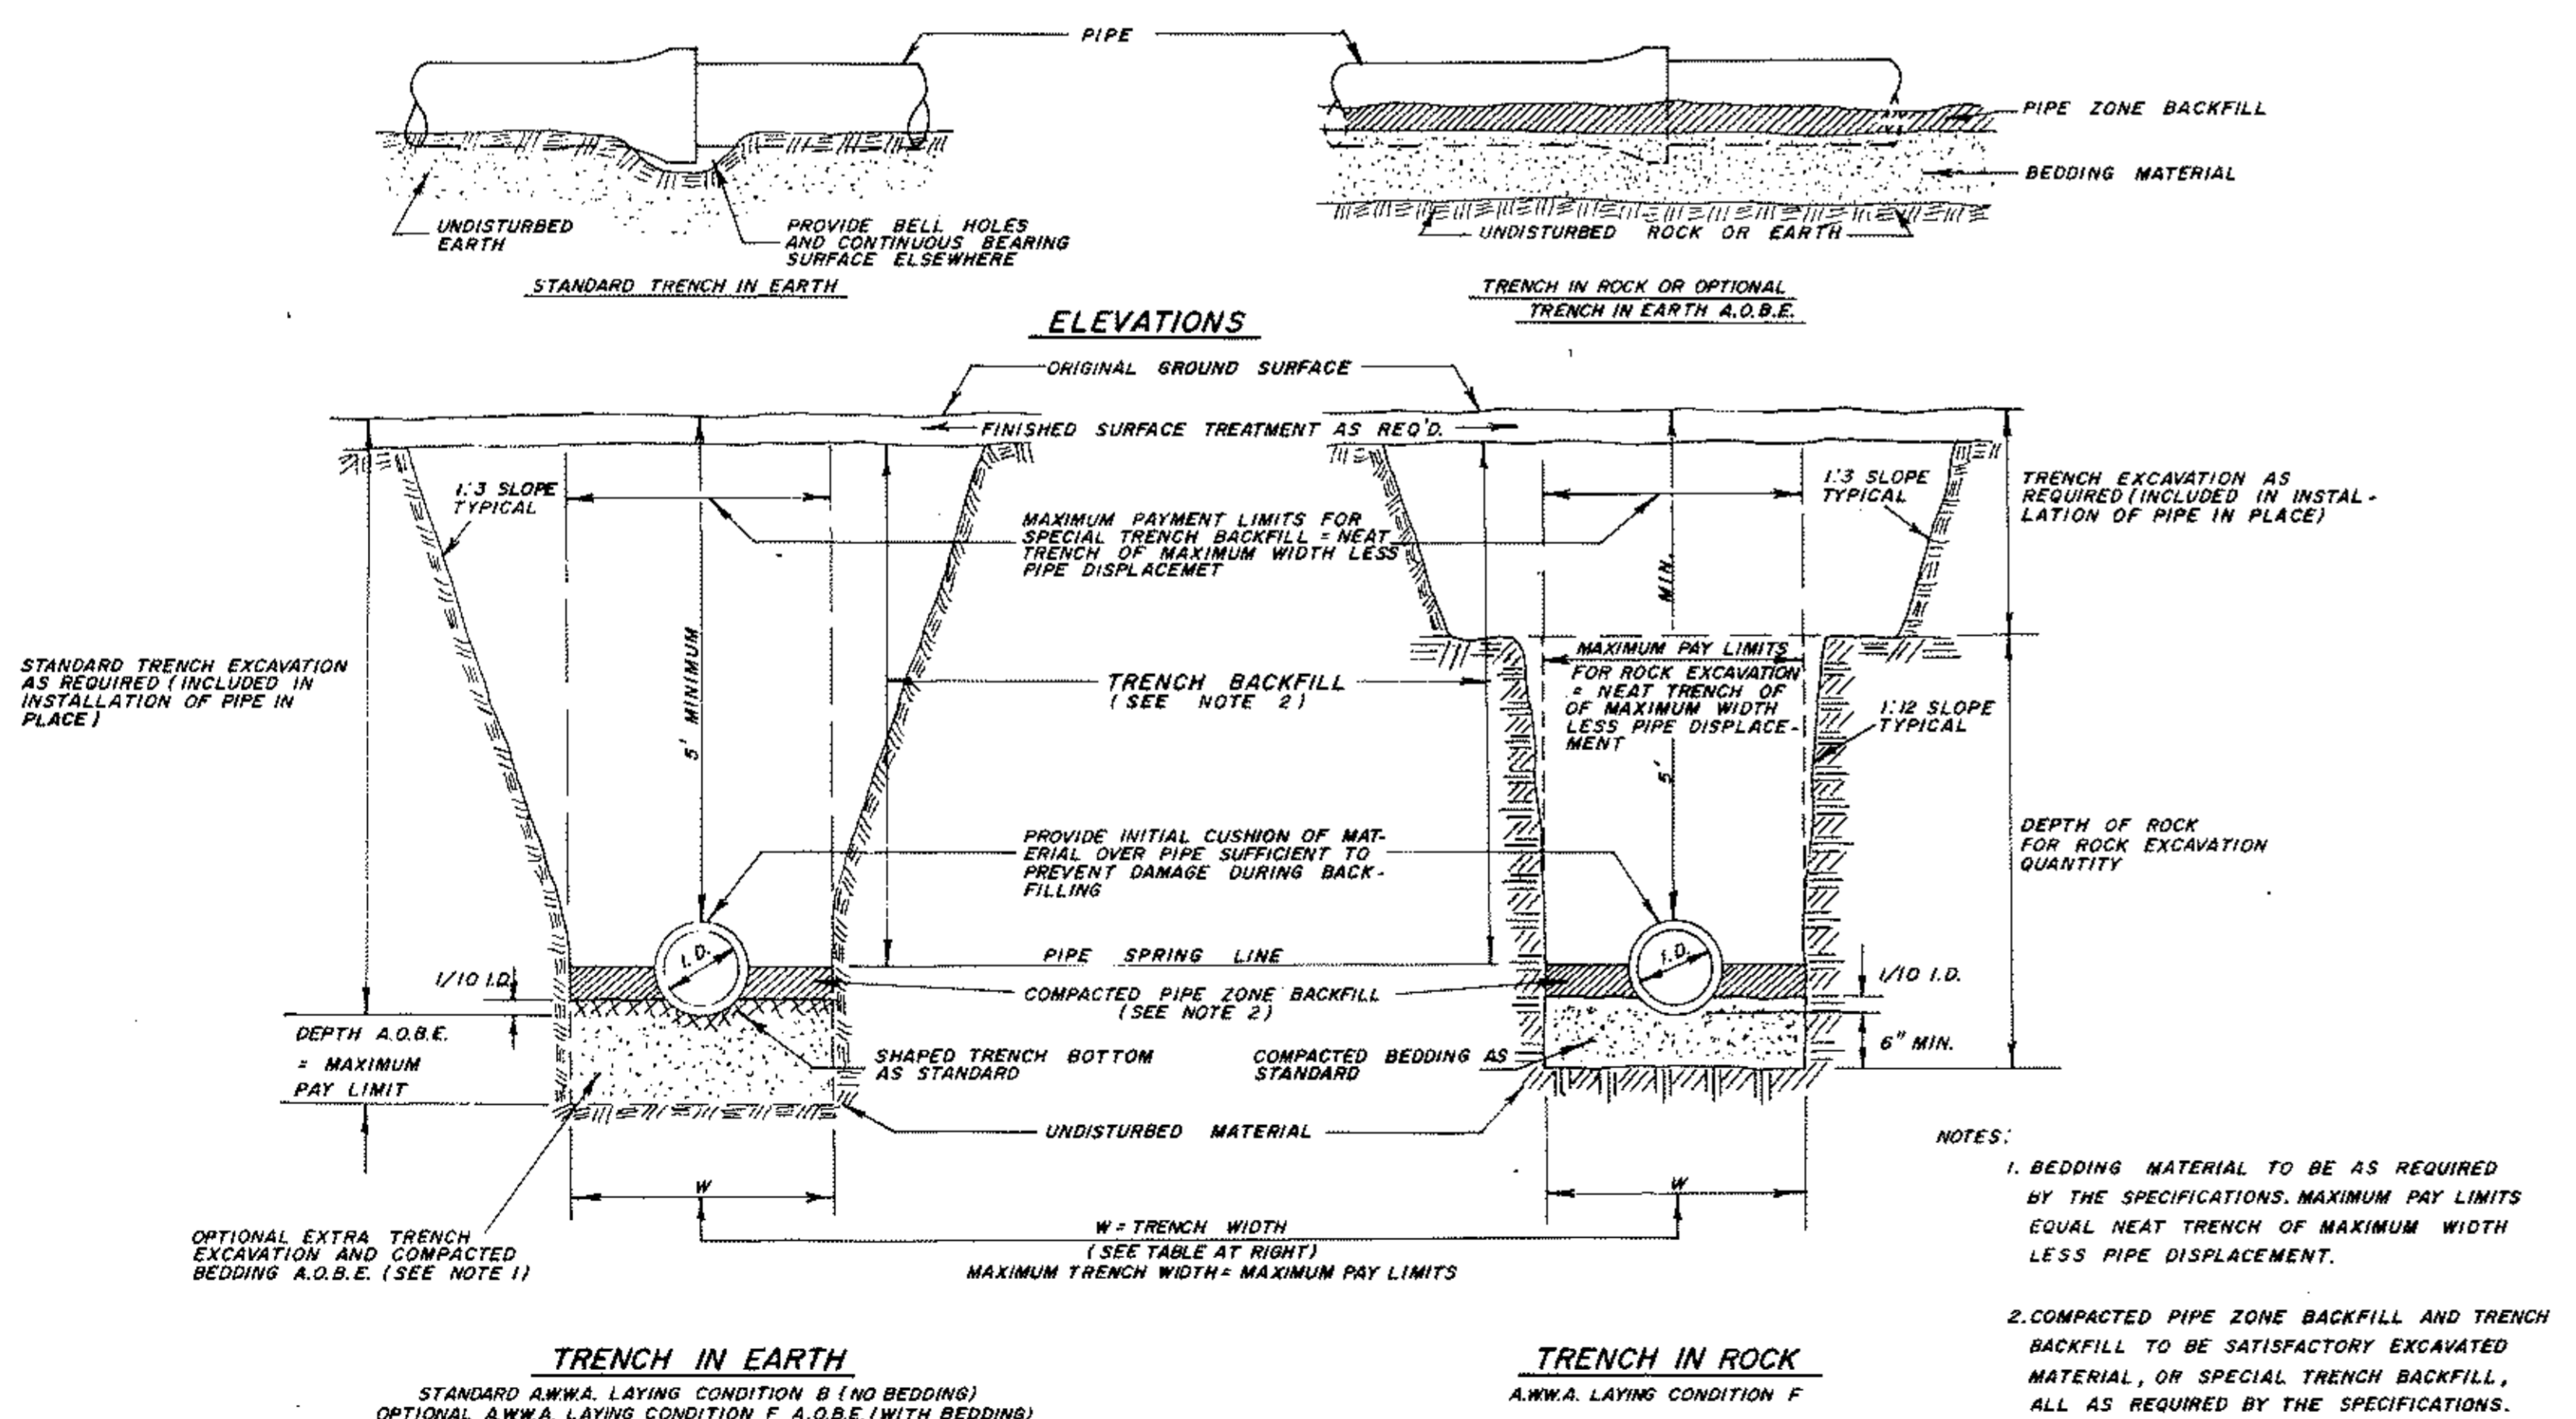
### TYPICAL TRENCH DETAILS

PIPE SIZE - I.D. (INCHES)	MIN. SUGGESTED TRENCH WIDTH FOR AMPLE WORKING SPACE (I.D. PLUS 15 INCHES)	MAX. TRENCH WIDTH ALLOWED - MAX. PAY LIMITS (I.D. PLUS 24")
2	17	26
3	18	27
4	19	28
6	21	30
8	23	32
10	25	34
12	27	36
14	29	38
16	31	40
18	33	42
20	35	44
24	39	48
30	45	54
36	51	60

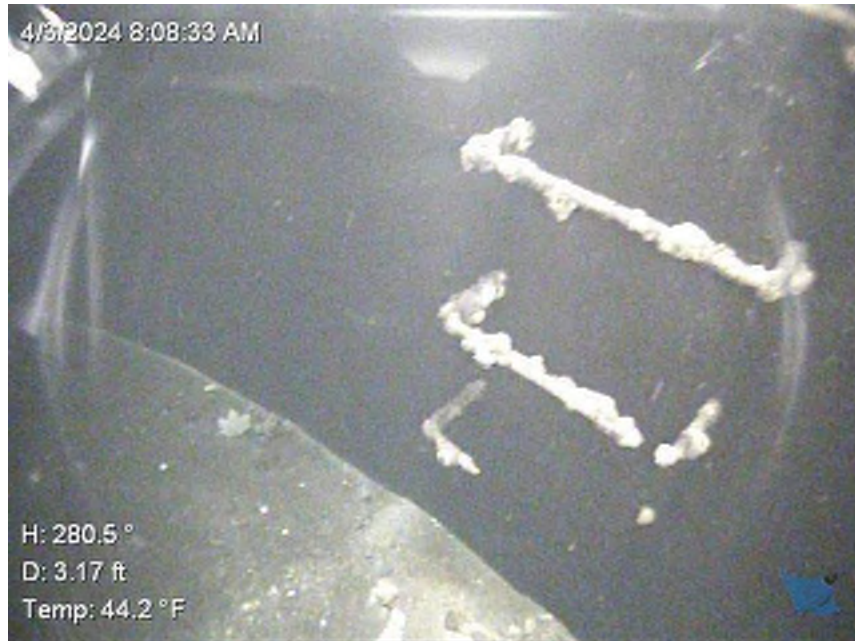
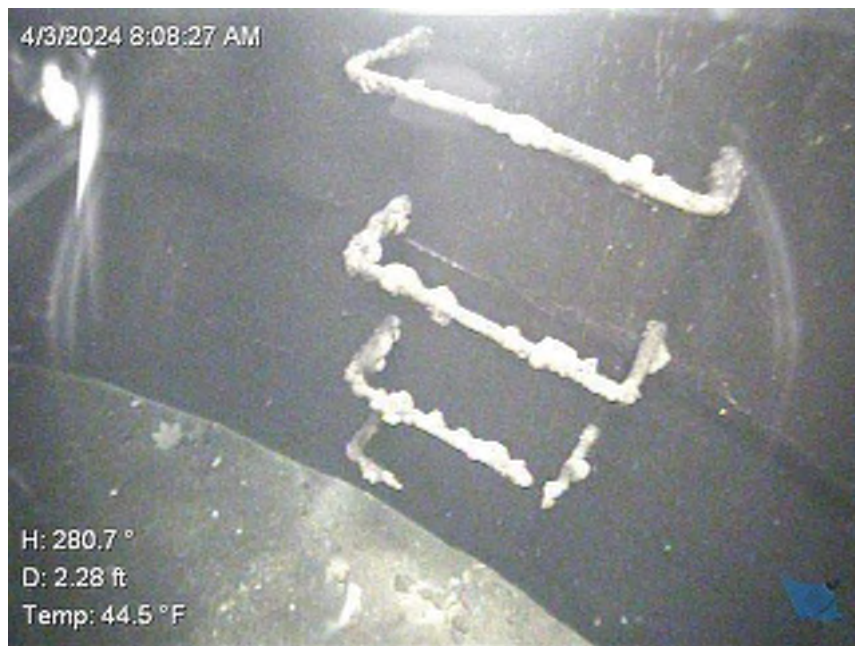
Damaged Ladder

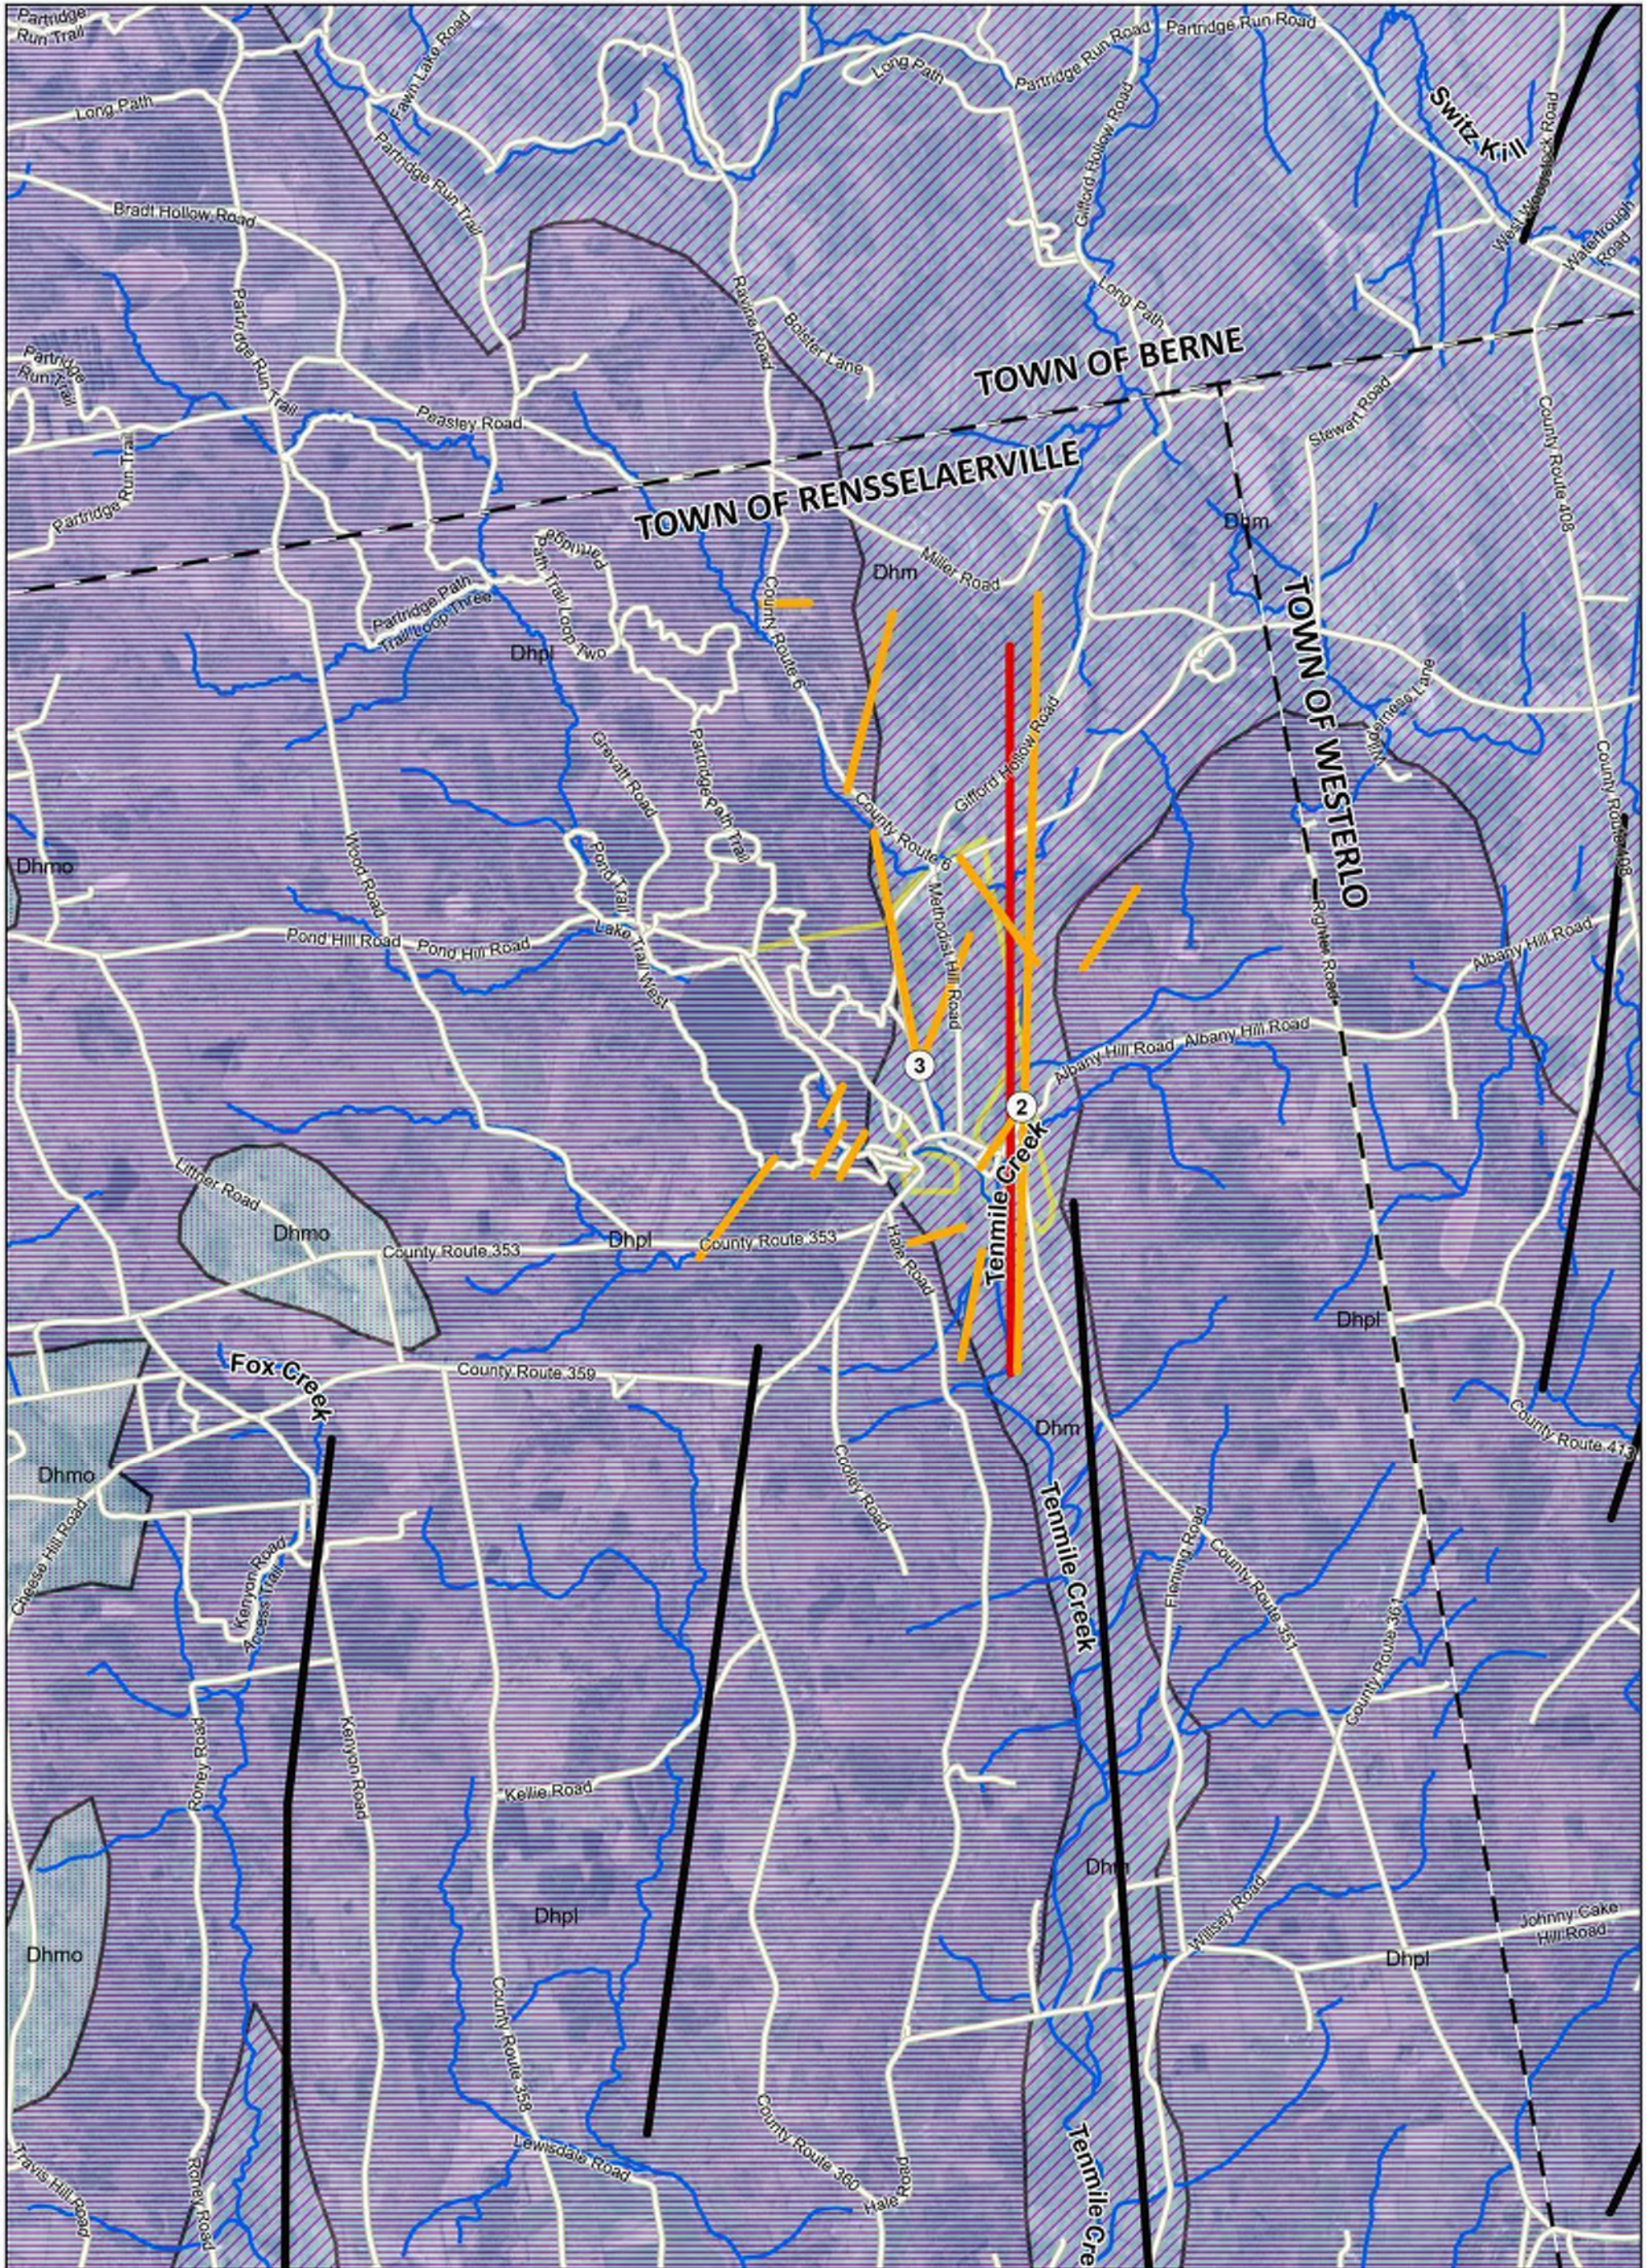
- Legend**
- Groundwater Target Area (C.T. Male, 2024)
  - Dhmo - Hamilton Group, Moscow Formation
  - Dhpl - Hamilton Group, Plattenkill Formation
  - Dhm - Undifferentiated Lower Hamilton Group
  - Hamlet of Rensselaerville
  - Stream/River
  - Streets/Roads
  - Town Boundary
  - Fracture Trace (Alpha Geoscience, 1995)
  - Lineament (Randall, 1995)
  - New York State Brittle Structures

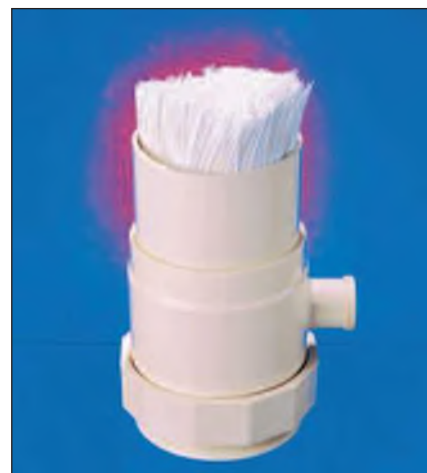
Module cutaway showing hollow fibers

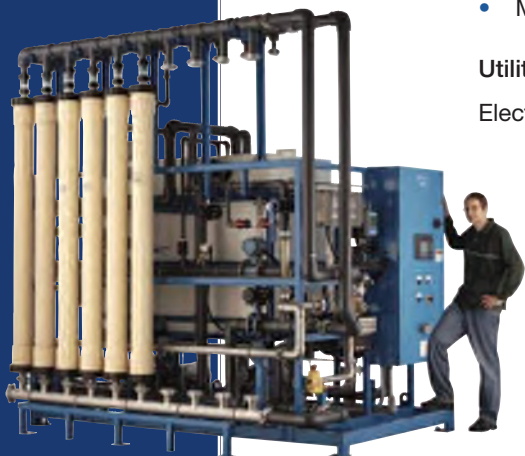
#### Microza Hollow Fiber Microfiltration Module<sup>9</sup>

- Membrane material: PVDF
- Pore rating: 0.1 micron ( $\mu\text{m}$ )
- Fiber OD/ID: 1.3 mm/0.7 mm
- Active filter area: 538 ft<sup>2</sup>
- Module size: 6" diameter x 79" long
- Housing: ABS
- Gasket: EPDM
- Potting material: Urethane

Feed water enters the bottom of the module and is distributed uniformly to the outside of the fibers. Since it is under pressure, the water passes through the hollow fiber membranes, and filtered water exits through the top of the module. Under normal conditions, all of the feed water flows through the membranes and exits as filtered water. Depending on the feed quality, a small amount of the feed water may be circulated past the outside of the hollow fibers. This flow prevents the accumulation of foulants and debris on the surface of the membrane and helps to evenly distribute flow through the membrane fibers.

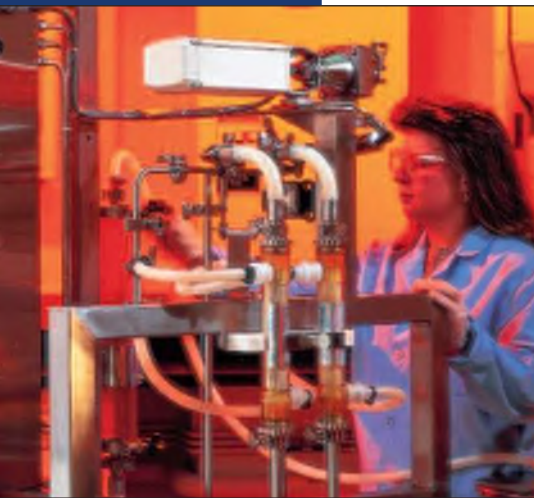
### Enhanced Flux Maintenance (EFM)

To ensure maximum efficiency and lowest total cost of ownership, Pall developed an enhanced cleaning technique to keep the membranes free of fouling materials. EFM is a fully automated process that uses water with mild chemical solutions to significantly reduce TMP. A reduction in TMP decreases pumping energy and results in fewer modules, which in turn scales down the system footprint and lowers facility heating and cooling costs.

The highly crystalline polyvinylidene fluoride (PVDF) hollow fiber membranes that are part of every Pall Aria AP system make EFM possible. These fibers are exceptionally strong and chemically resistant, with a life of 10+ years, even with daily EFM. When changes in water conditions make EFM unnecessary, the on-board control system disables it, increasing efficiency of the Pall Aria AP system.

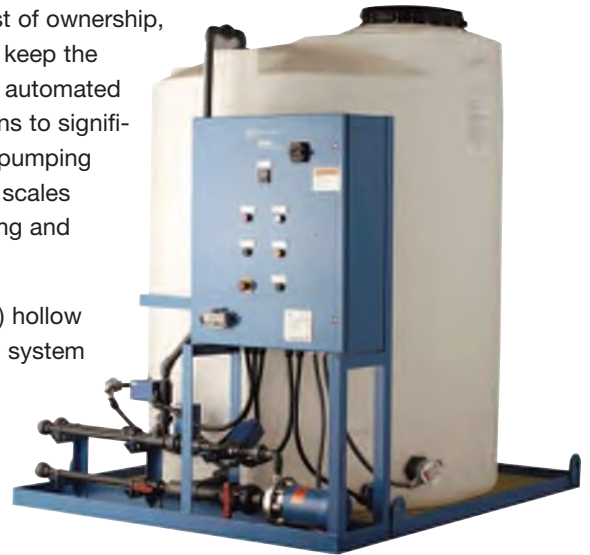
### Chemical Clean-in-Place (CIP)

Backwash and EFM are designed to remove particulate matter and foulants. In most applications, it will occasionally be necessary to execute a complete CIP process. The CIP process is a two-step protocol using a caustic solution with chlorine and an acidic solution. This process will return the modules to nearly new condition and can be performed hundreds of times over the life of the modules.

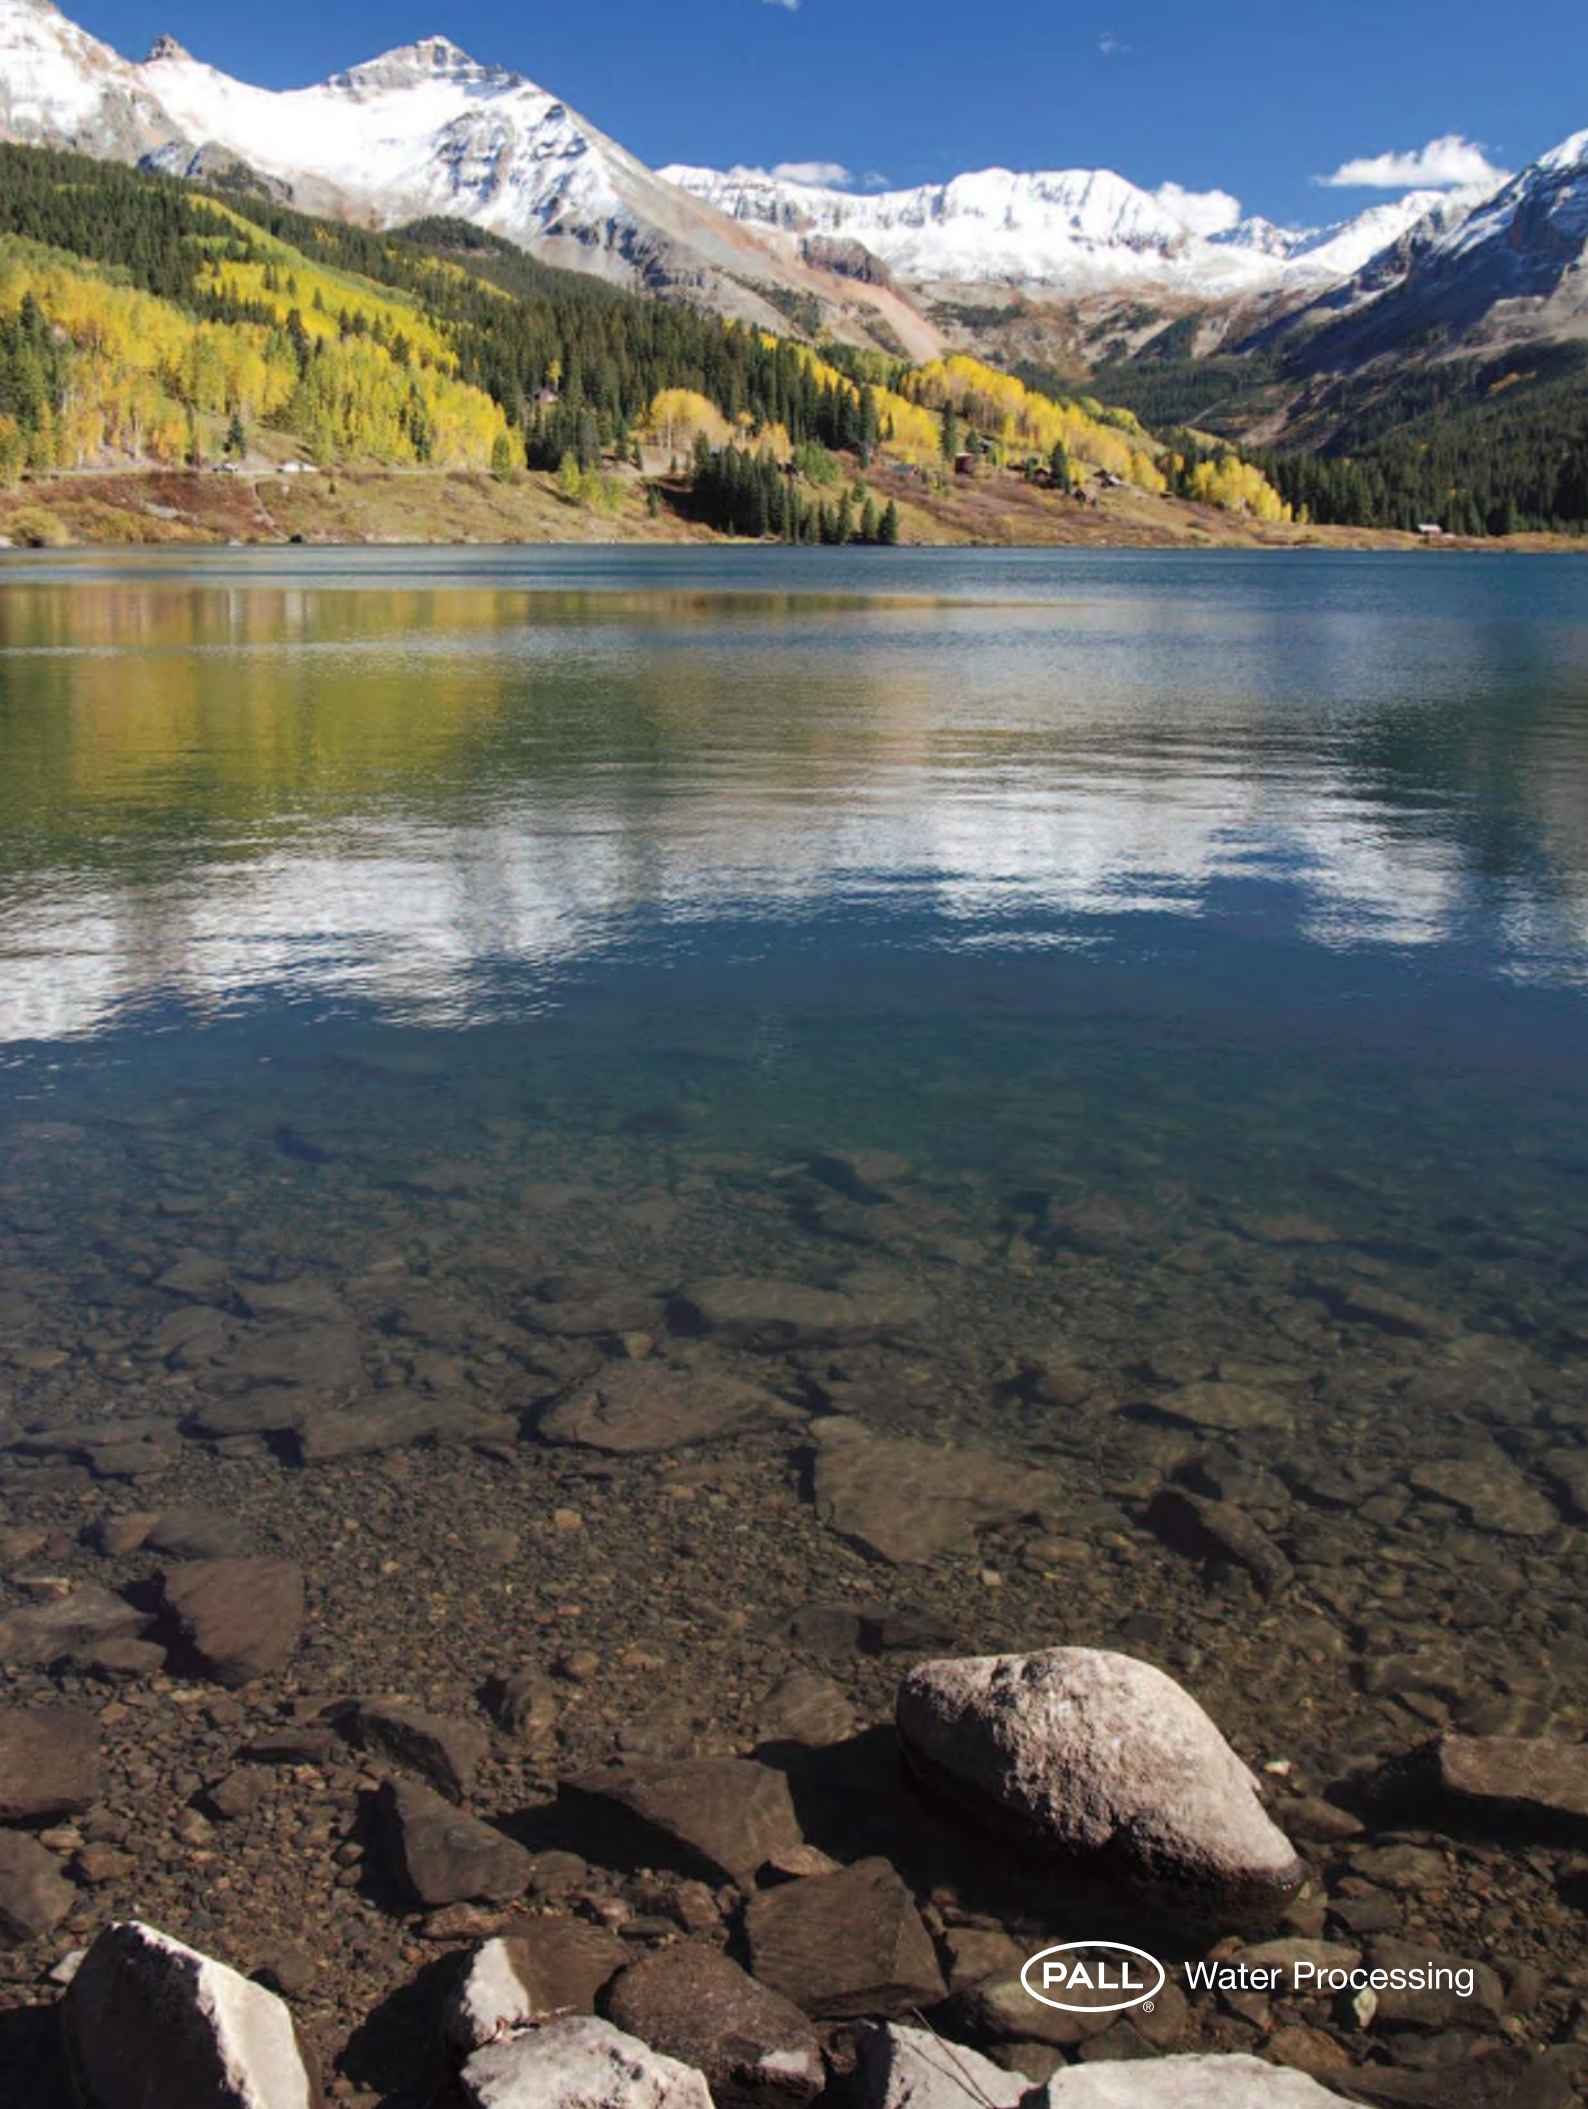
- THE MODULE RACK ASSEMBLY AND INTERCONNECT PIPING ASSEMBLY WILL BE SHIPPED LOOSE FOR INSTALLATION IN THE FIELD.
- THIS DRAWING SHOWS (1) COMPLETE AP4 ASSEMBLY.

- THE DISKS ON ELASTOMER-SEATED BUTTERFLY VALVES MUST BE AT LEAST PARTIALLY OPEN WHEN TIGHTENING FLANGE BOLTS. FAILURE TO DO SO WILL CAUSE PREMATURE FAILURE, AND WILL VOID ALL WARRANTIES ON THE VALVE.
